Analysis of Landslide at Gudar-Gedo Road and Proposal of Mitigation Measures

Abstract- *landslides are common problem in hilly or mountainous area. The various causes affect the landslides, namely, soil properties, geological properties and meteorological properties. The present study deals with the study of landslide occurred in GUDAR and GEDO road section at GUDAR place – in Oromia region of Ethiopia. Therefore, this study particularly aimed at investigating geotechnical characteristics, type of soil and their role in landslide initiation, slope stability analysis and to recommend possible remedial measures.*

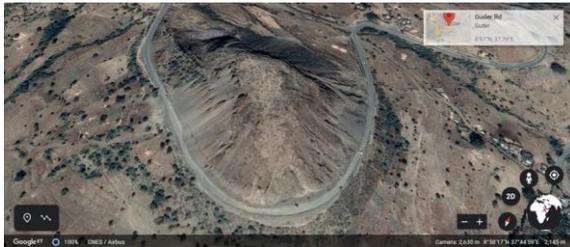
The area is near GUDAR town, the journey around 5 km from GUDAR town towards GEDO, which passes through a hilly area reach to the research area. The area is at 8°58' N and 37°44' E, the location is about to 2228 m above sea level. The landslide area is with very loose soil with longitudinal hexagonal shape rock fragmentation.

The below fig shows the actual site of landslide area.
